**Cornell University**  
**Environmental**  
**Health and Safety**

## MEMO

**Subject:** JanFab – Upson Hall

EHS conducted various site inspections and monitoring of different work activities during the time frame called JanFab within B70, B70E Upson Hall and 101 of Upson Automotive Lab. Attendees included Phil VanChieri, Greg Smith, and Blaine Harteis, EHS.

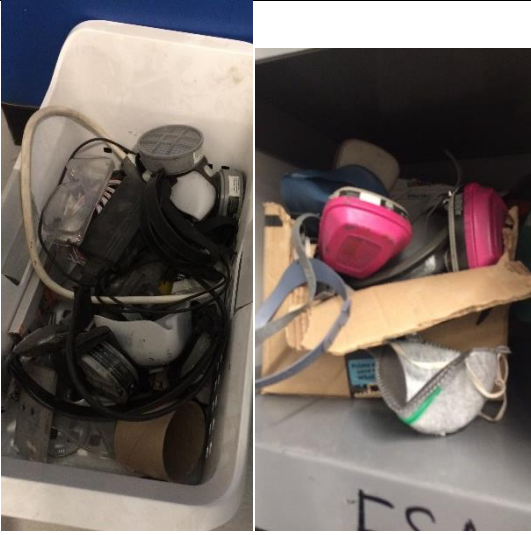
Finding	Photo	Requirement
<p>Upson Hall – B70 – There are various containers/bins with previously used half-face respirators with cartridges attached.</p>

<p>Recommend removing and disposing of half-face respirators.</p>
<p>Upson Hall - B70E- bench top drill presses and floor stand vise are not bolted down.</p>

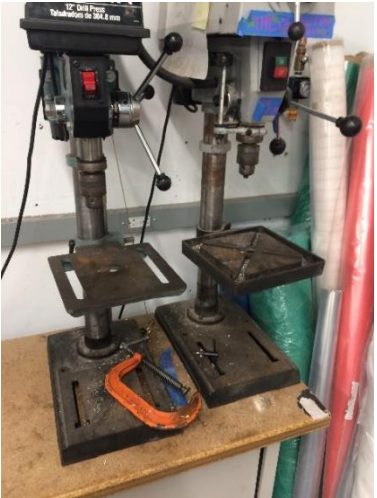
<p><b>1910.212(b)</b> Anchoring fixed machinery. Machines designed for a fixed location shall be securely anchored to prevent walking or moving.</p>

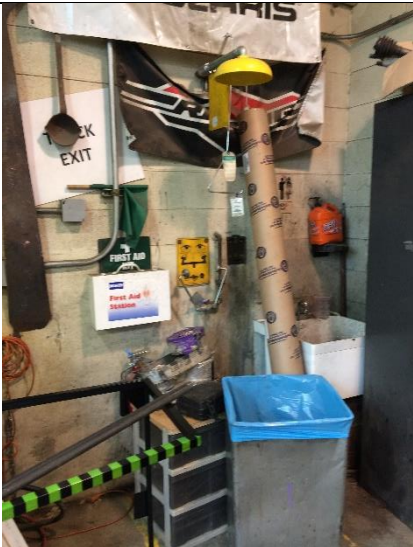
<p>Upton Automotive Lab – 101 – Emergency eyewash and shower blocked by various items.</p>

<p><b>CU Lab Safety Manual – 5.5.1 Testing and Inspection of Emergency Eyewash and Showers –</b> The units need to be maintained so the unit is not obstructed.</p> <p>Recommend installing demarcating tape on the floor minimum of 3ft and/or signage on the wall to prevent items from being stored directly in front of the unit(s).</p>
<p>Upton Automotive Lab – 101 – There are multiple grinding units (not all grinders are pictured) that are missing work rests or the work rests and tongue guards are too far from the wheel.</p>

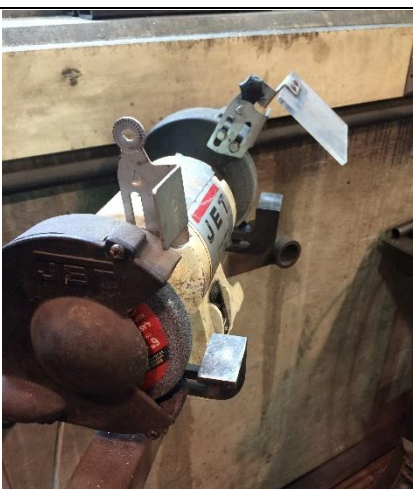
<p><b>1910.215(a)(4)</b></p> <p>Work rests shall be used to support the work. Work rests shall be kept adjusted closely to the wheel with a maximum opening of one-eighth inch to prevent the work from being jammed between the wheel and the rest, which may cause wheel breakage.</p> <p><b>1910.215(b)(9)</b> The distance between the wheel periphery and the adjustable tongue or the end of the peripheral member at the top shall never exceed one-fourth inch.</p>

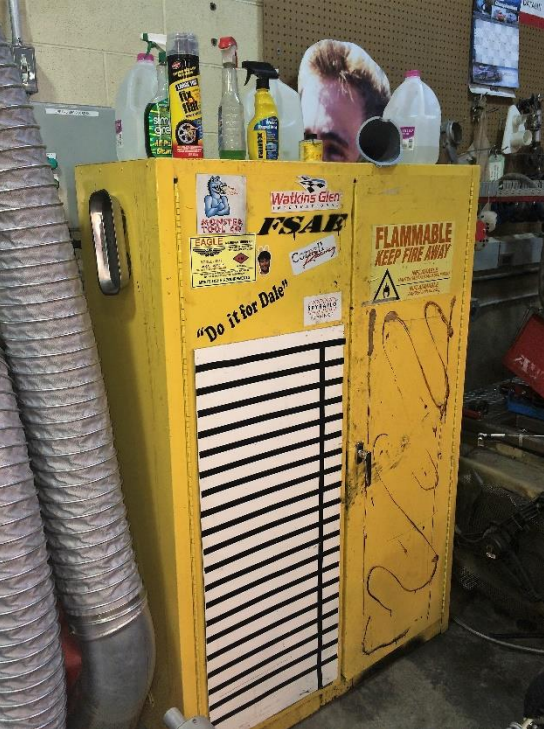
<p>Upton Automotive Lab – 101 – The flammable cabinet does not securely close, latching handle has no closure assembly.</p>

<p><b>1910.106(d)(3)(ii)(a)</b></p> <p>Metal cabinets constructed in the following manner shall be deemed to be in compliance. The bottom, top, door, and sides of cabinet shall be at least No. 18 gage sheet iron and double walled with 1 1/2 - inch air space. Joints shall be riveted, welded or made tight by some equally effective means. The door shall be provided with a three-point lock, and the door sill shall be raised at least 2 inches above the bottom of the cabinet</p>

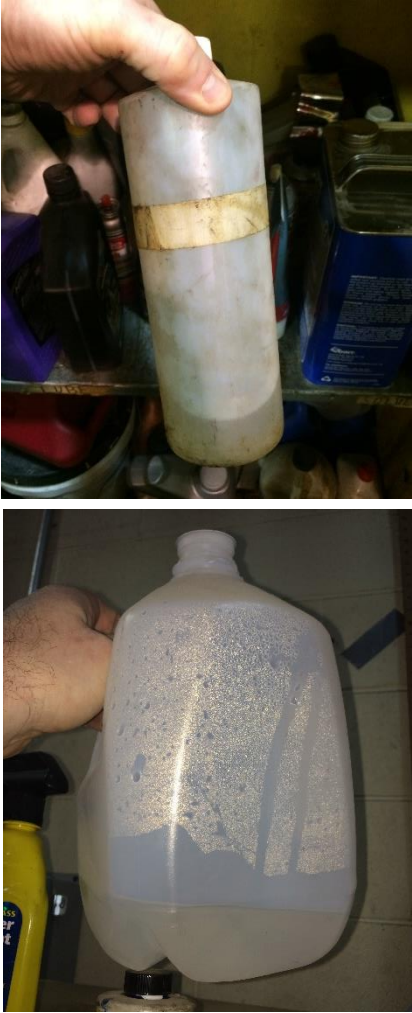
<p>Upson – B70 and Upson Automotive Lab – 101 – various chemical containers labels have faded or not labeled. Also liquids in containers do not coincide with contents.</p>

<p><b>OSHA 1910.1200(f)(2)</b></p> <p>Chemicals must be labeled. When a hazardous chemical or product is transferred from the original container, or the label becomes illegible or falls off, a new label with all the elements of the original manufacturers label must be affixed.</p> <p><b>CU Lab Safety Manual – 7.8.2 Labeling requirements –</b>  All chemical containers (both hazardous and non-hazardous) <b>MUST</b> be labeled. Chemical names must be written out in English. If a label is starting to fall off a chemical container or is becoming degraded, then the container needs to be relabeled (using tape, permanent marker, OSHA secondary labels, etc.) or the chemical needs to be transferred to another properly labeled container.</p>

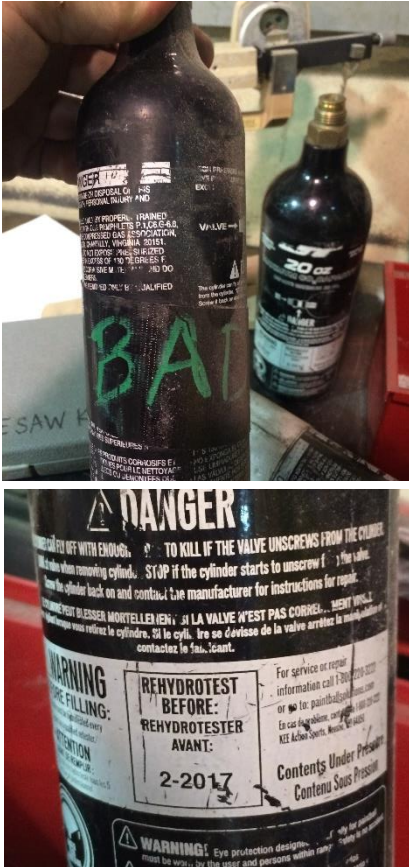
<p>Upson Automotive Lab – 101 – compressed air/gas cylinders past hydrotest date</p>

<p><b>49 CFR 180.209</b>  <b>Requirements for <u>requalification</u> of specification cylinders.</b></p> <p>(a) <i>Periodic qualification of cylinders.</i> Each specification <u>cylinder</u> that becomes due for periodic <u>requalification</u>, as specified in the following table, must be requalified and marked in conformance with the requirements of this subpart</p>

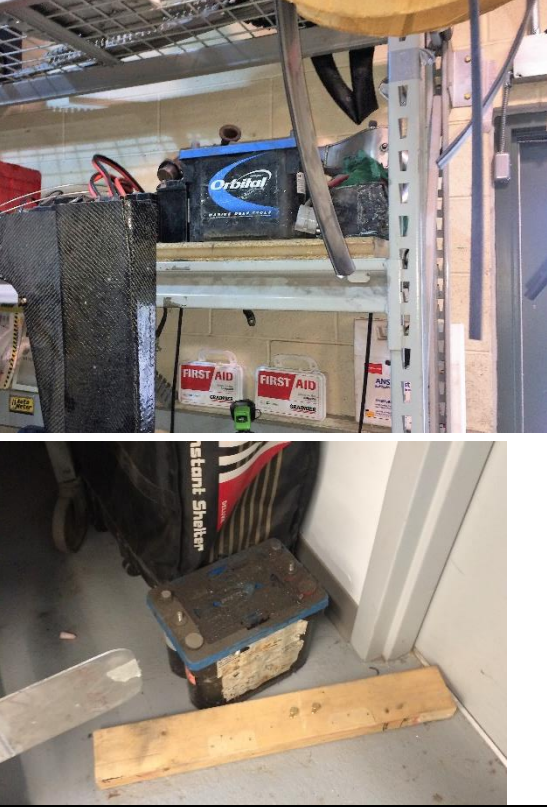
Finding	Photo	Requirement
<p>Upton Hall – B70 and Automotive Lab – 101 – inadequate vehicle battery storage.</p>

<p>Recommend batteries be stored in or on secondary containment in order to prevent any leakage of battery acid on to floor. Also recommend storing batteries on a lower shelf/floor level to prevent potential liquid spillage when removing.</p> <p>Contact R5 if batteries are be recycled.</p>
<p>Upton – B70 – maintaining egress</p>

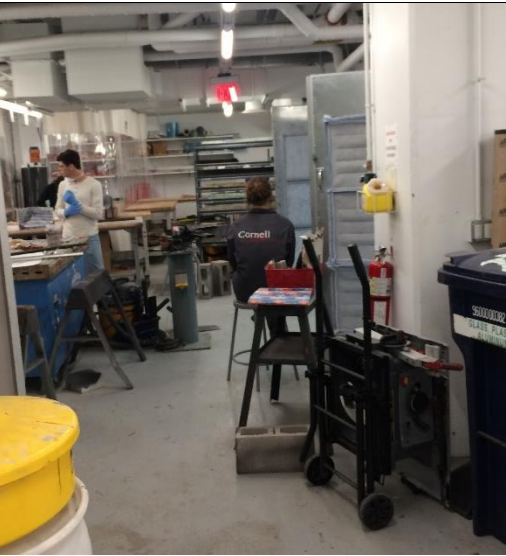
<p><b>1910.37(a)(3) egress general</b></p> <p>Exit routes must be free and unobstructed. No materials or equipment may be placed, either permanently or temporarily, within the exit route. The exit access must not go through a room that can be locked, such as a bathroom, to reach an exit or exit discharge, nor may it lead into a dead-end corridor. Stairs or a ramp must be provided where the exit route is not substantially level.</p>

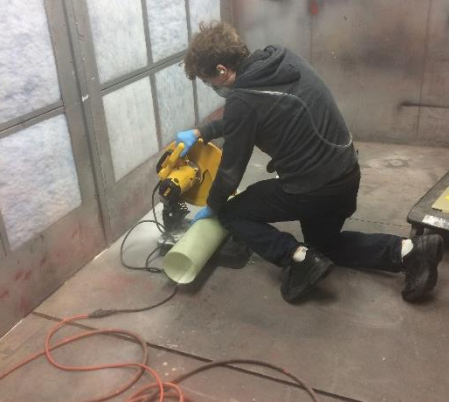
<p>machine is removed to keep egress path clear</p>
<p>Upton Hall – B70 – Inadequate working surface, improper gloves, Awkward posture/improper ergonomics. Power cords pose a tripping hazard.</p>

<p>Recommended giving the miter saw a designated working surface that avoids students getting into awkward positions or that are ergonomically hazardous. Specifically, on a table that is at a comfortable height for the user. Cover the power cord or place them where students cannot trip over them.</p> <p>Position saw so the cuttings/dust is in the direction of the air flow within the paint booth.</p>

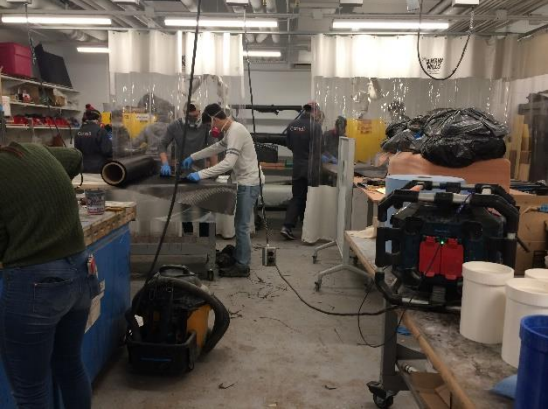
Finding	Photo	Requirement
<p>Upson – B70 – Power cords and vacuum are blocking a means of egress.</p>

<p><b>OSHA 1910.22(a)(3)</b>  Walking-working surfaces are maintained free of hazards such as sharp or protruding objects, loose boards, corrosion, leaks, spills, snow, and ice.</p>
<p>Upson – B70 – Tool use.</p>

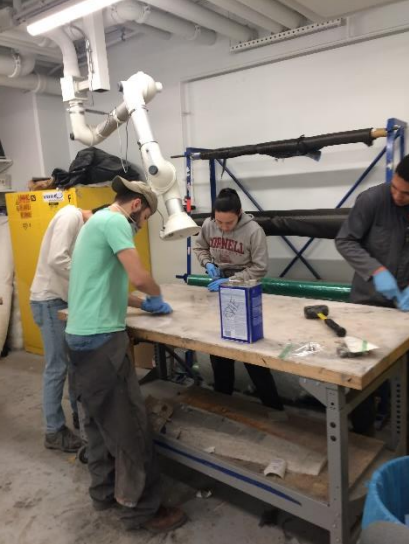
The ventilation of the snorkel units were smoke tested to observe the draw of the unit(s). The result of the testing showed that the snorkels have a draw capability of approximately one foot in distance from cone beyond that distance the capture is minimum to none. Recommend increasing exhaust fan motor for the units or investigate alternative exhaust capturing devices.

Finding	Photo	Requirement
<p>Upson – B70 – Snorkels have minimum distance capture. Inadequate PPE while removing chemicals.</p>

<p>Recommend that students work as close to the snorkels as possible. When removing hardened resins and/or using chemical solvents to release hardened material wear the appropriate PPE such as gloves, eye protection, long sleeves.</p>
<p>Upson Automotive Lab – No local exhaust ventilation in the area to collect the hazardous fumes</p>

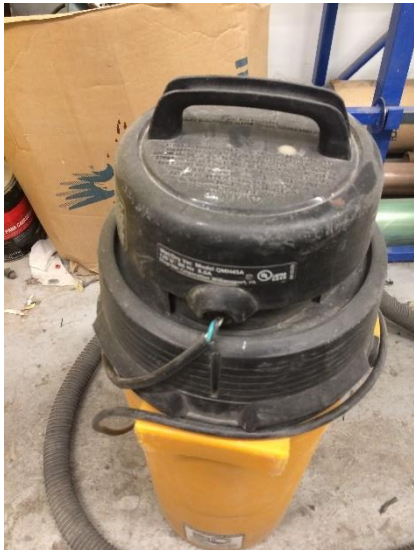
Finding	Photo	Requirement
Upson – B70 – Exposed wiring

<b>OSHA 1910.334(a)(2)(ii)</b>  If there is a defect or evidence of damage that might expose an employee to injury, the defective or damaged item shall be removed from service, and no employee may use it until repairs and tests necessary to render the equipment safe have been made.
<b>General findings:</b>  <b>Injuries:</b> Report any injuries sustained using the online form found at the following link - <a href="https://rmeps-prod.hosting.cornell.edu/accinj/">https://rmeps-prod.hosting.cornell.edu/accinj/</a>

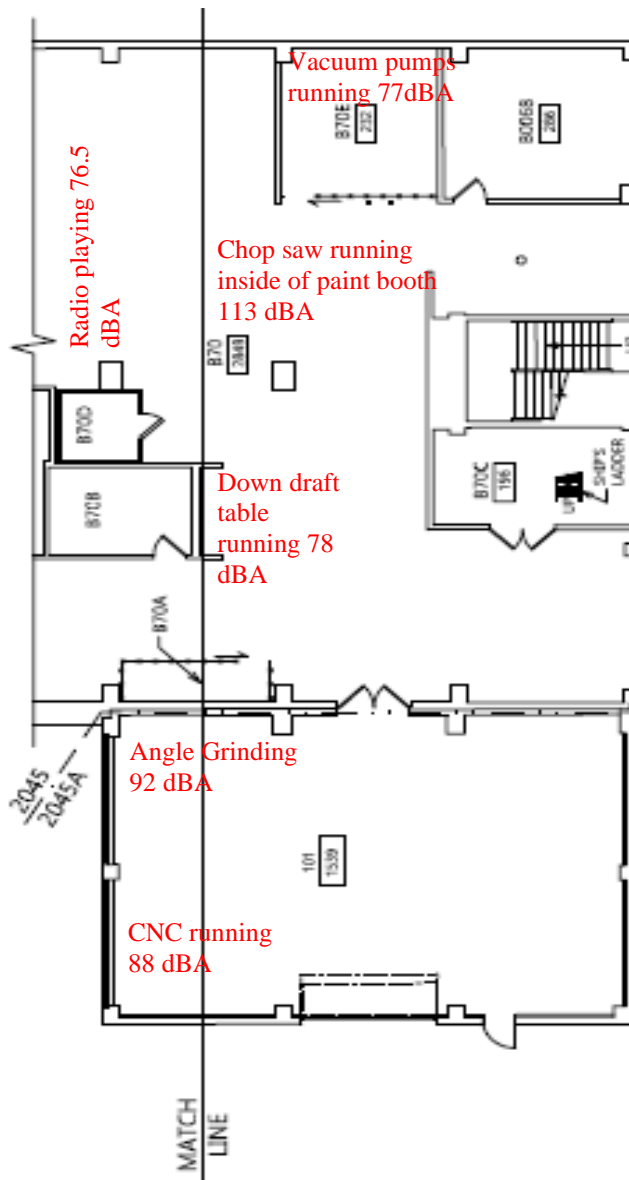
## Noise Results from 1/14/20

Results with no equipment running were between 70-72 dBA. Room B70 experienced levels between 95-97 dBA with the chop saw running inside of the paint booth.

Hearing protection becomes required when noise levels meet or exceed 85dBA.
