AE Progress Report 12.19.08

Cuatro Comunidades

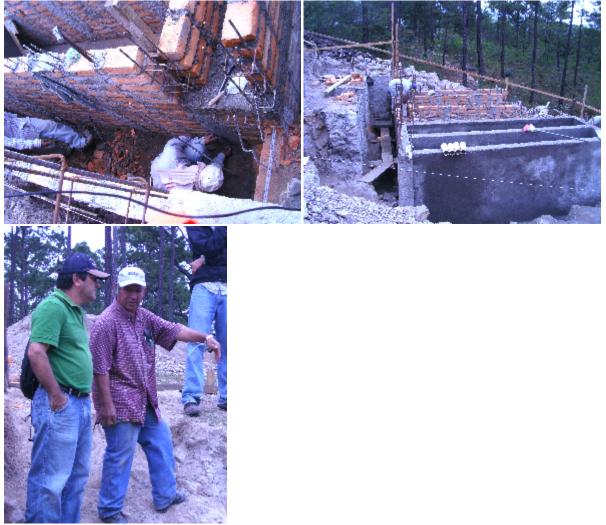
Wil, John and Tamar went to the construction site on Monday 12.15. The walls of the flocculation tank are plastered with cement, and the other remaining walls are standing with bricks. We decided the depth of the exit channel should be the same as the exit box. Originally it was supposed to be deeper. We also decided upon the exact location of the 3 drain pipes for each sed tank (one for the drain manifold, one for cleaning floating foam the top of the tanks, and one for draining the sludge box at the end of the tank). We realize it is important to define exactly where all the pipes will go in the drawings in the future.
