# Fall 2008 Paint Test

## Fall 2008 Paint Test

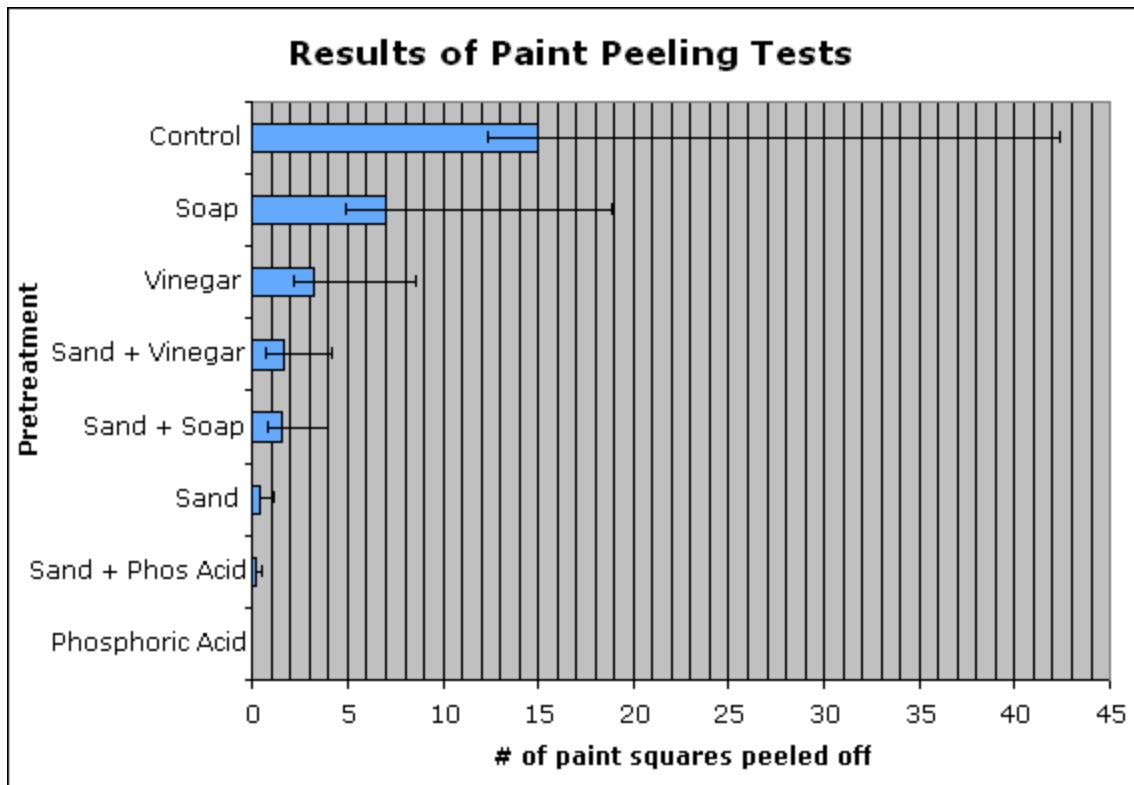
error bars represent 95% confidence intervals

As can be seen from the above chart, the phosphoric acid pretreatment worked the best, followed by sanding plus phosphoric acid pretreatment, followed by sanding pretreatment. However, the difference between the results for phosphoric acid pretreatment and sanding plus phosphoric acid pretreatment were not statistically significant (their confidence intervals overlap). The difference between the sanding plus phosphoric acid pretreatment and the sanding pretreatment was not statistically significant either, however the difference between the phosphoric acid pretreatment and the sanding pretreatment was statistically significant.

Our recommendation to Mujeres Solares is that they use phosphoric acid as a pretreatment before using their solar ovens. However, for reasons of cost and availability, that may not be practical. In that case, we suggest the sanding pretreatment, which is nearly as effective, and would likely be cheaper and easier. Any pretreatment at all is probably better than no pretreatment (although the differences between soap pretreatment and control were not statistically significant). The probable reason why control performed so poorly, as well as the reason for its very large standard deviation, is that finger oils on the metal can cause the paint to peel quite easily wherever it has been handled. For this reason, we emphasize the need to not touch the metal between the pretreatment and the painting.
