AguaClara

Low Flow Stacked Rapid Sand Filter

Dhaval Mehta, Ariel Seidner, Sarah Sinclair, Lishan Zhu

Cornell University

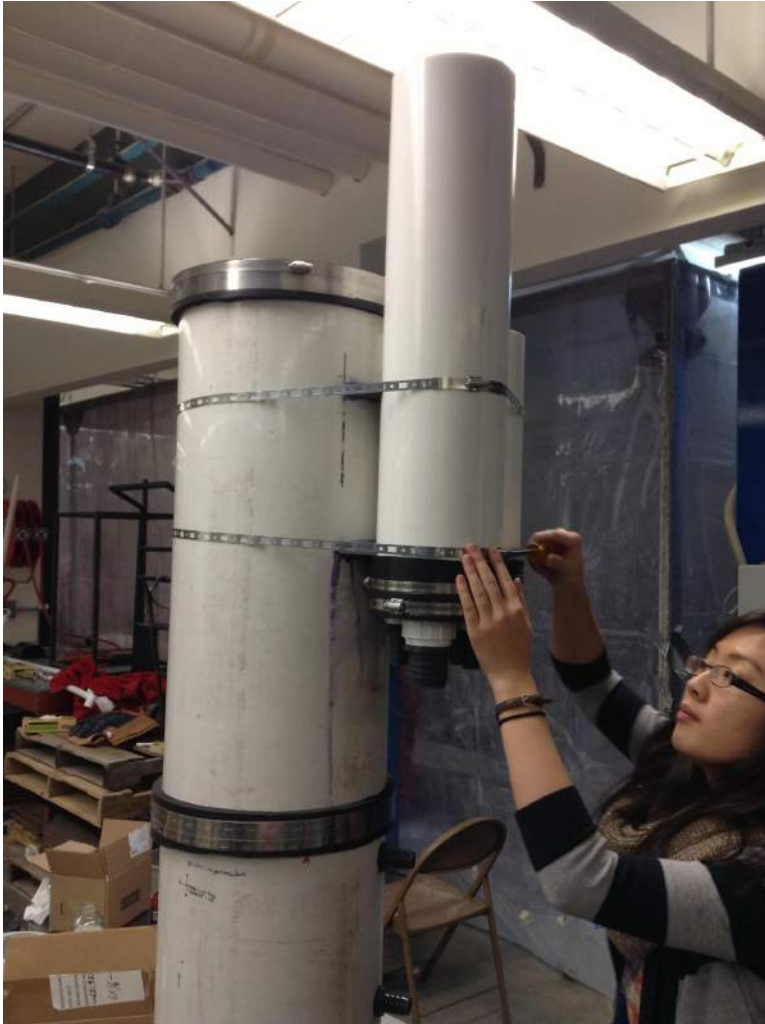
The Filter

- What are the filter parts?
- Two modes:
 - Filtration
 - Backwash
- What is the path of water/dirt?

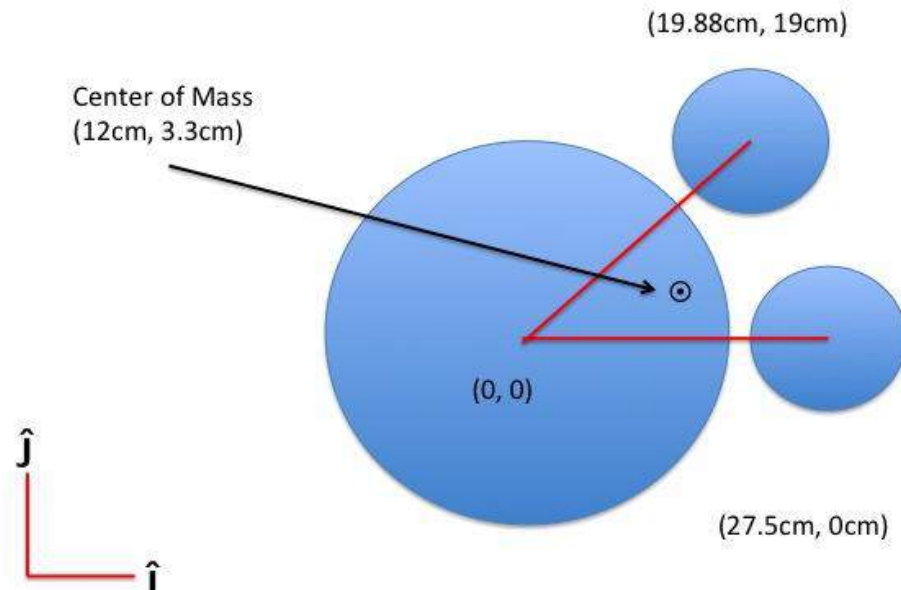
Column Stability

- Worst Case Scenario
- Additional Factor of Safety
- Center of Mass within Column

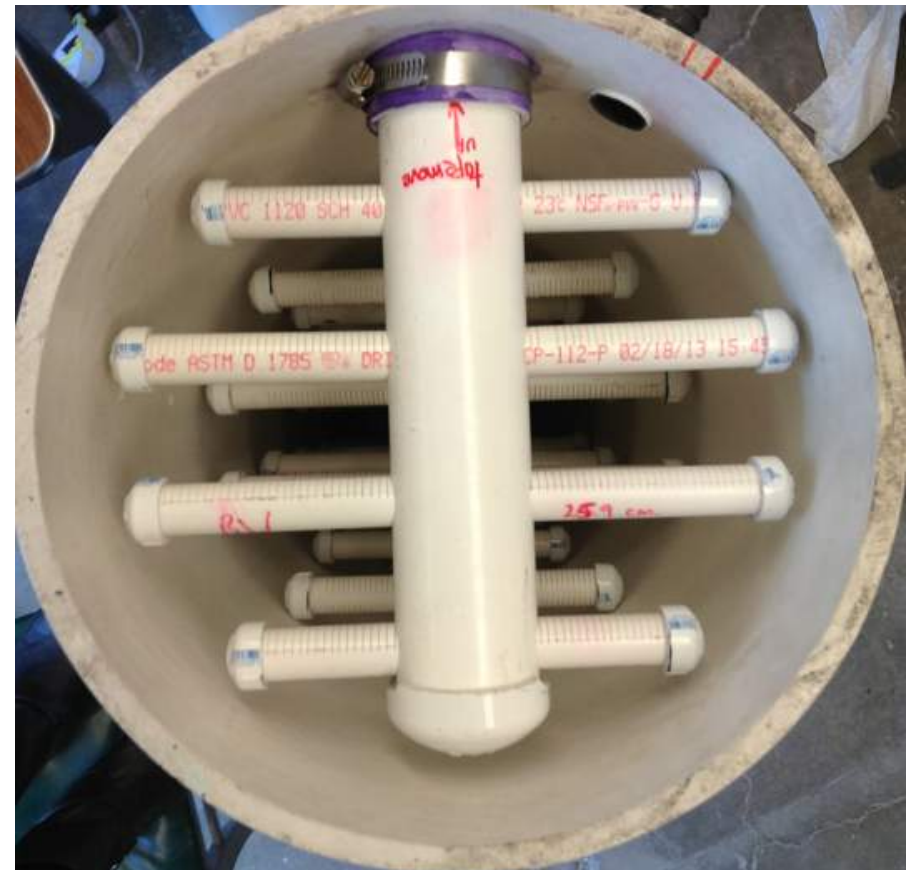
Design Constraints

- Circular Body
- Backwash head loss
- 0.5 inch manifolds
 - Area available on short(er) trunks
- Forward filtration head loss

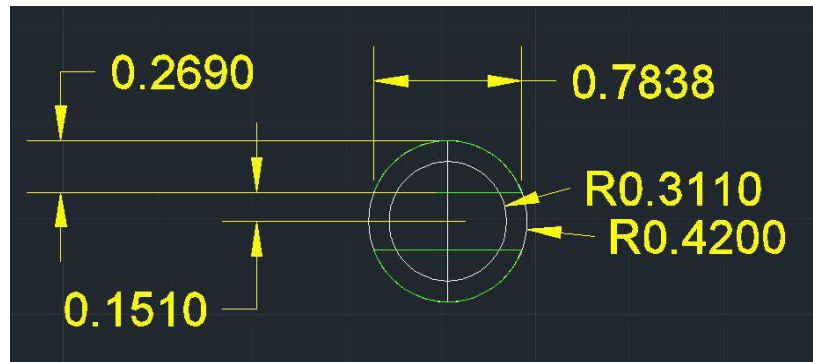
- 0.2 mm width, 3.175 mm ($\frac{1}{8}$ inch) spacing
- Manifolds on 1 inch trunks:

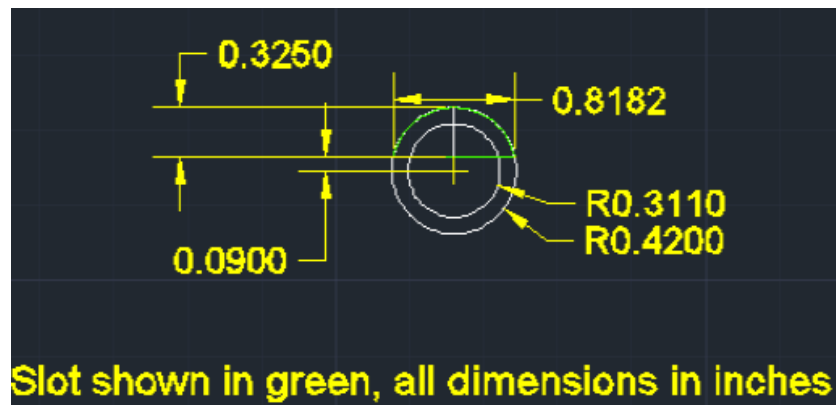
- Manifolds on 2 inch (backwash) trunks:

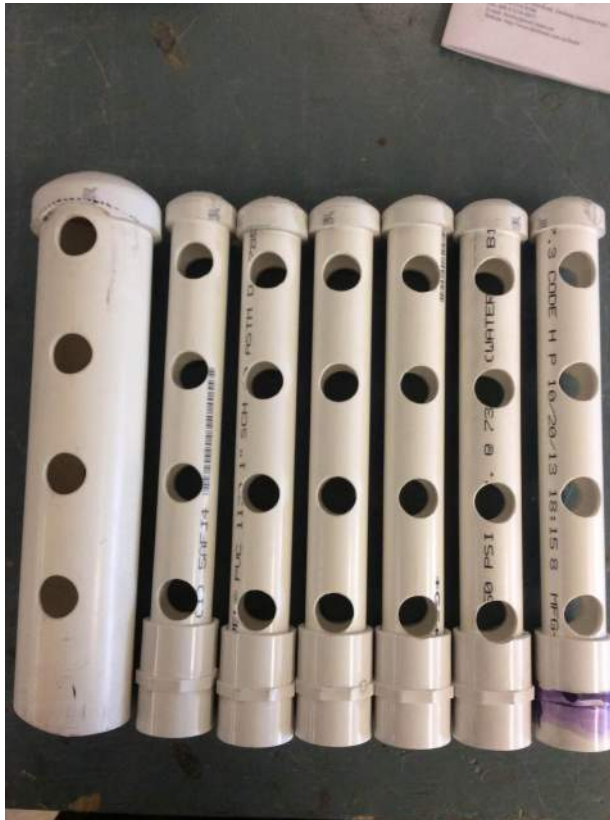
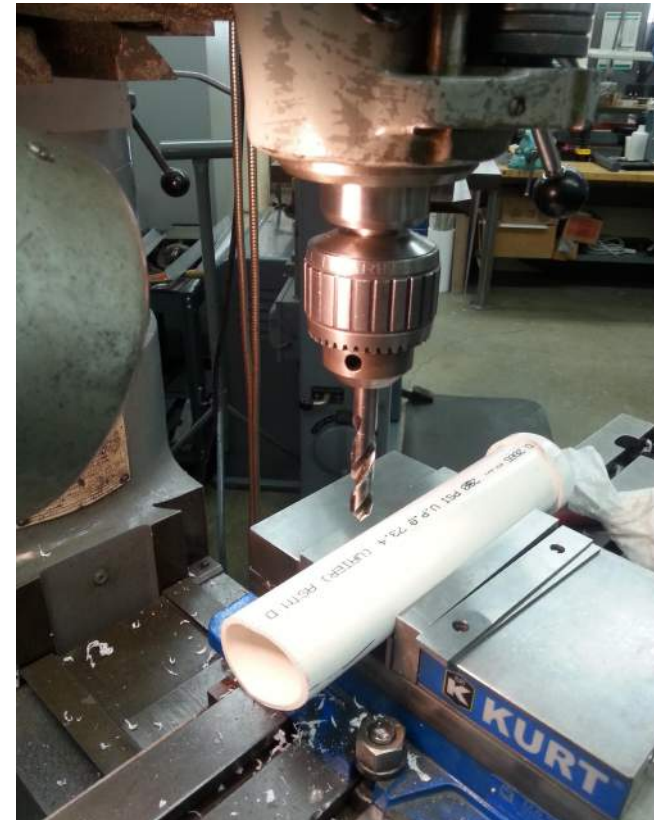
Assembly

- Precise drilling
- Manifold specifications critical for performance

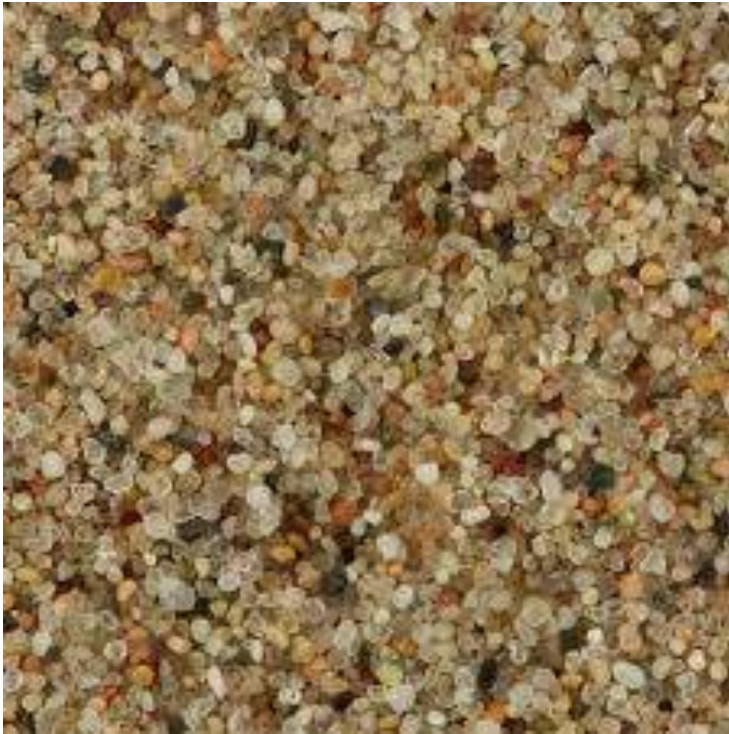
Sand Specs

Design Specs:

d10: 0.5mm

UC: 1.6

Delivered Specs:

d10: 0.45 mm

UC: 1.4

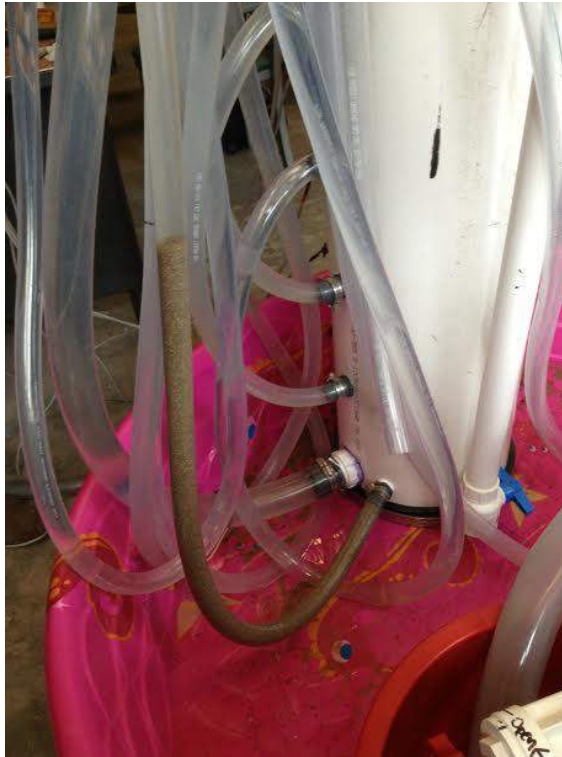
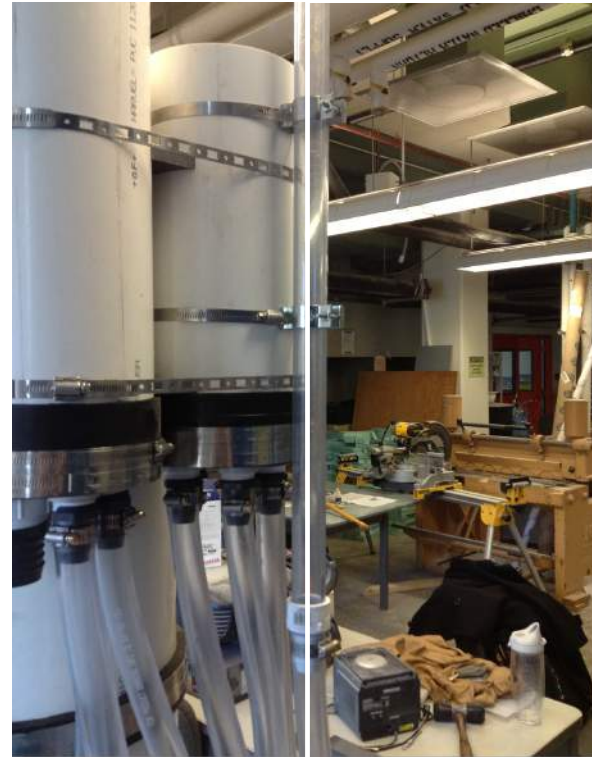
Sand Drain

- Extends above water level to stop flow
- Acts as manometer

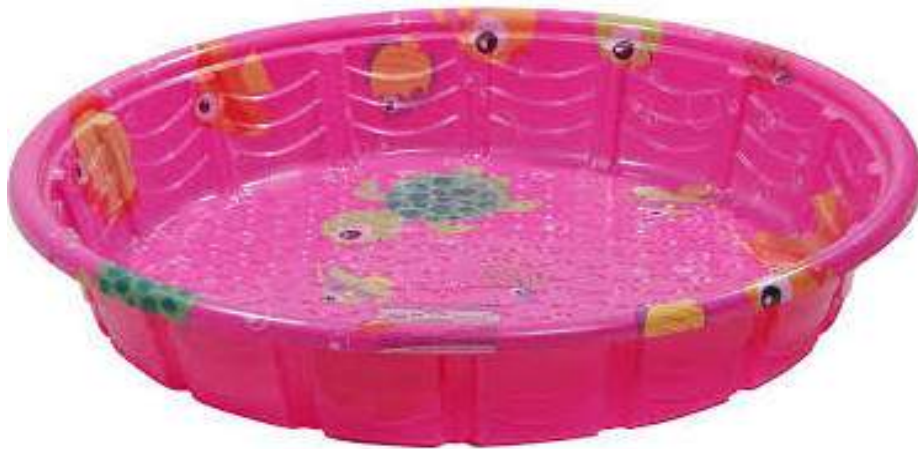
- Recycling system
 - 2.34 m head, 0.8 L/s

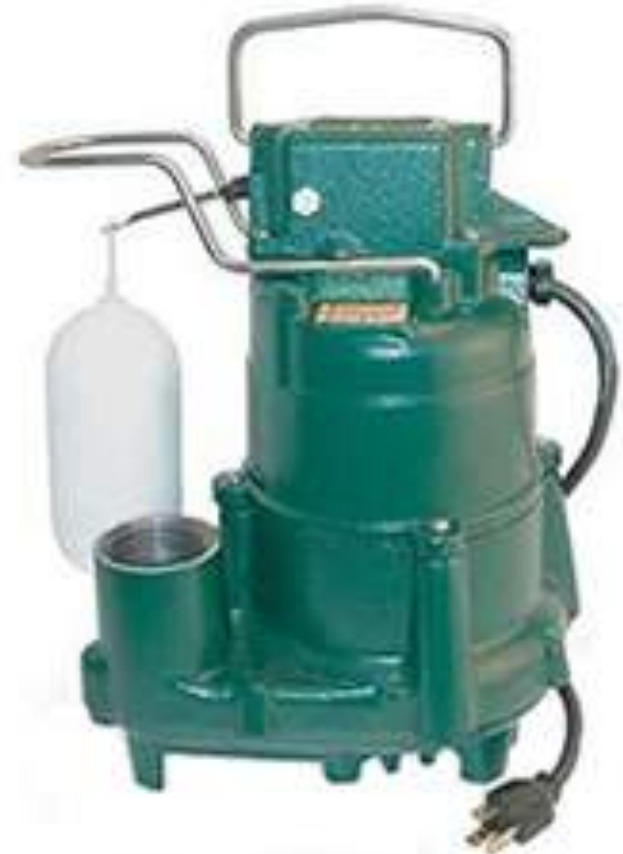
- Secondary containment

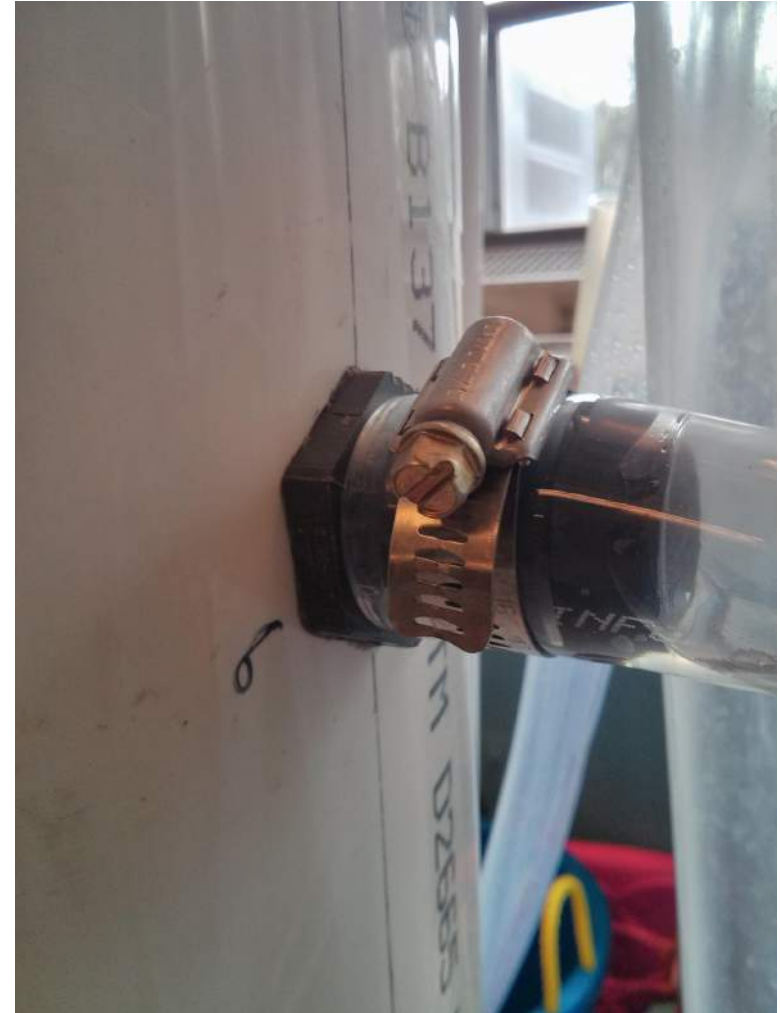
Fixed Leaks

- Inlet/outlet flexible tubing connections
- Glued tank coupling connections
- Middle gasket leak

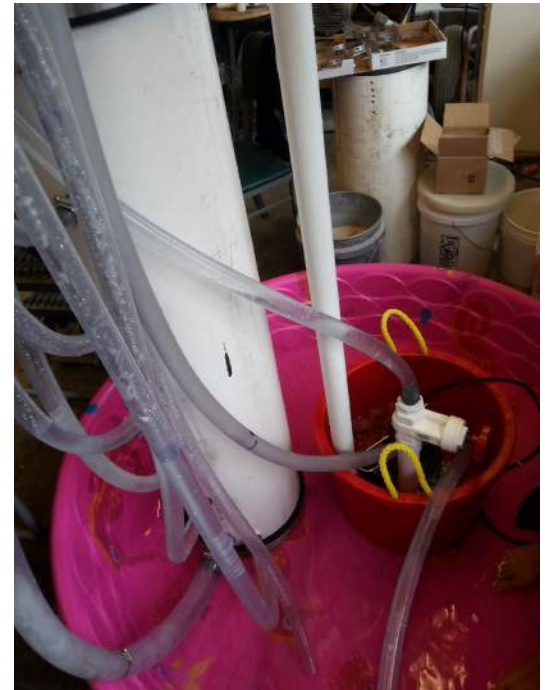
AguaClara Air Leaks and Solutions

- Switching from normal filtration to backwash
- Why must there be no air in the filter column?
 - Set up and maintain backwash siphon
- Where can air enter from?
 - Entrance tank
 - Exit tank
 - Backwash pipe
 - Filter body

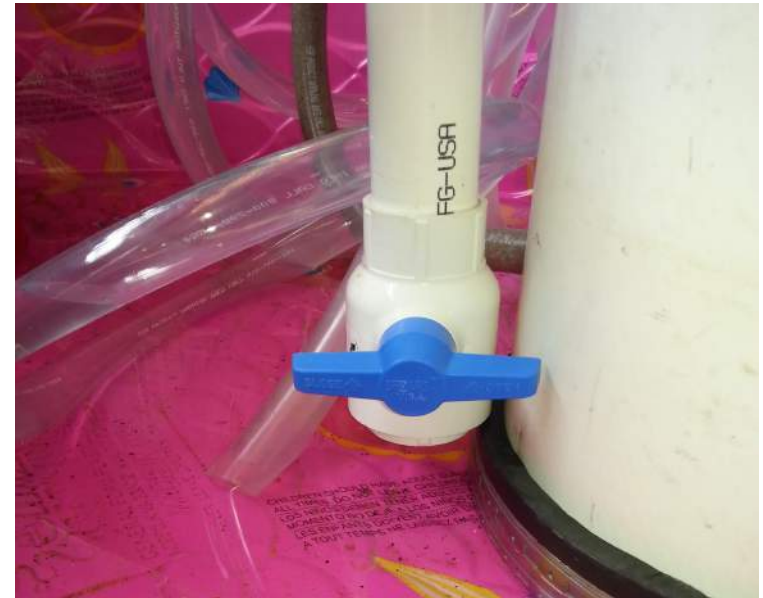
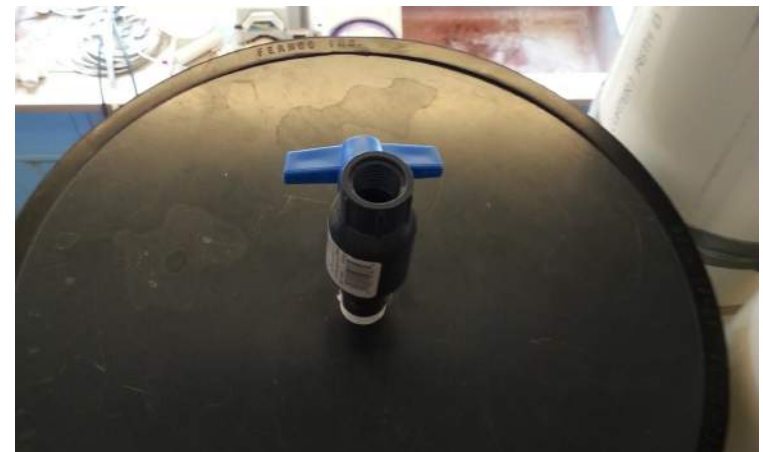
Switching from Forward Filtration to Backwash

- Present Solutions
 - (Temporary) valves
 - Long Term Solutions
 - Redesign valve placement on backwash-to-waste pipe
 - Raise effluent weir in exit tanks (and thus exit and entry tank heights)

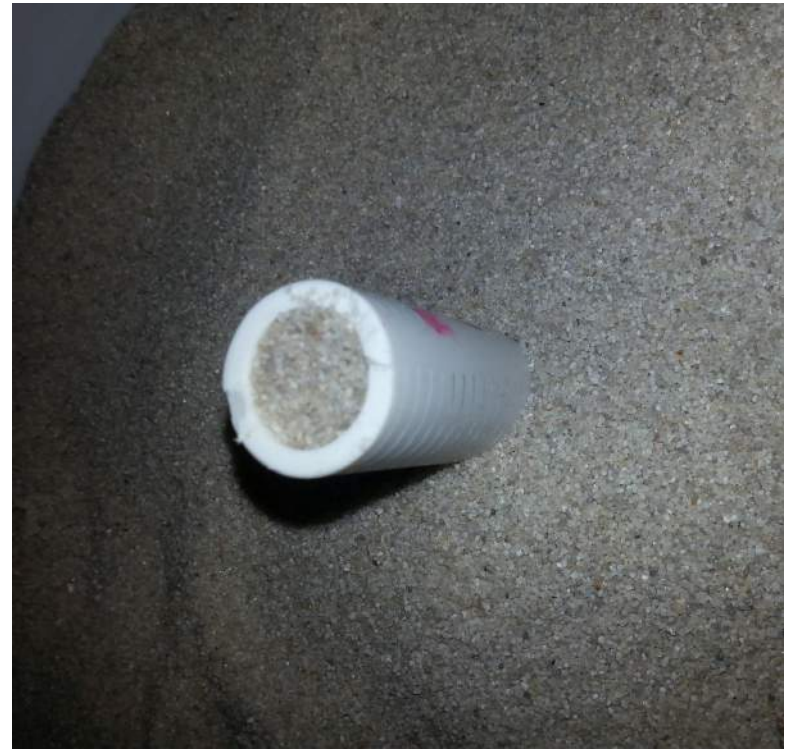
AguaClara Accounting for Head Loss

- Entrance tank backing up at target flow rate during backwash
- Excessive head loss
- Four suspects
 - Sand in manifold
 - Bed fluidization
 - Slot area
 - Cross section
- Two discarded

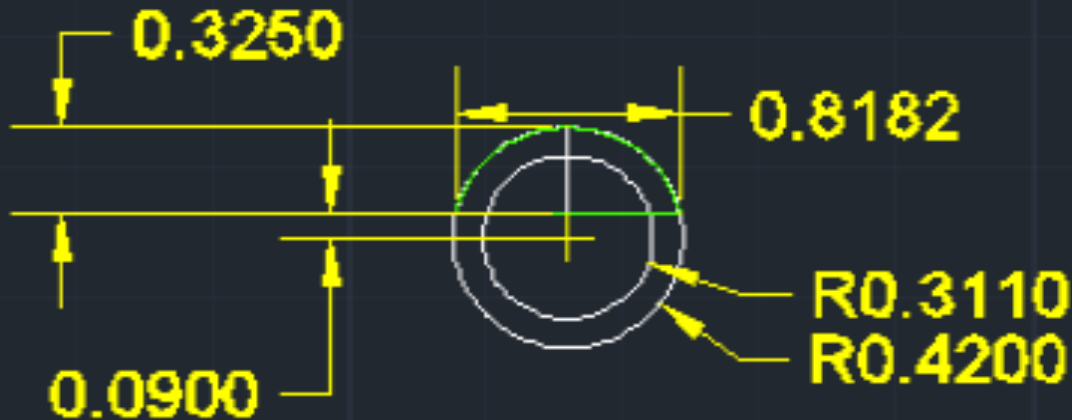
Slot Area: Faulty Manufacturing?

- Burrs
- Does not satisfy specifications?

Slot shown in green, all dimensions in inches

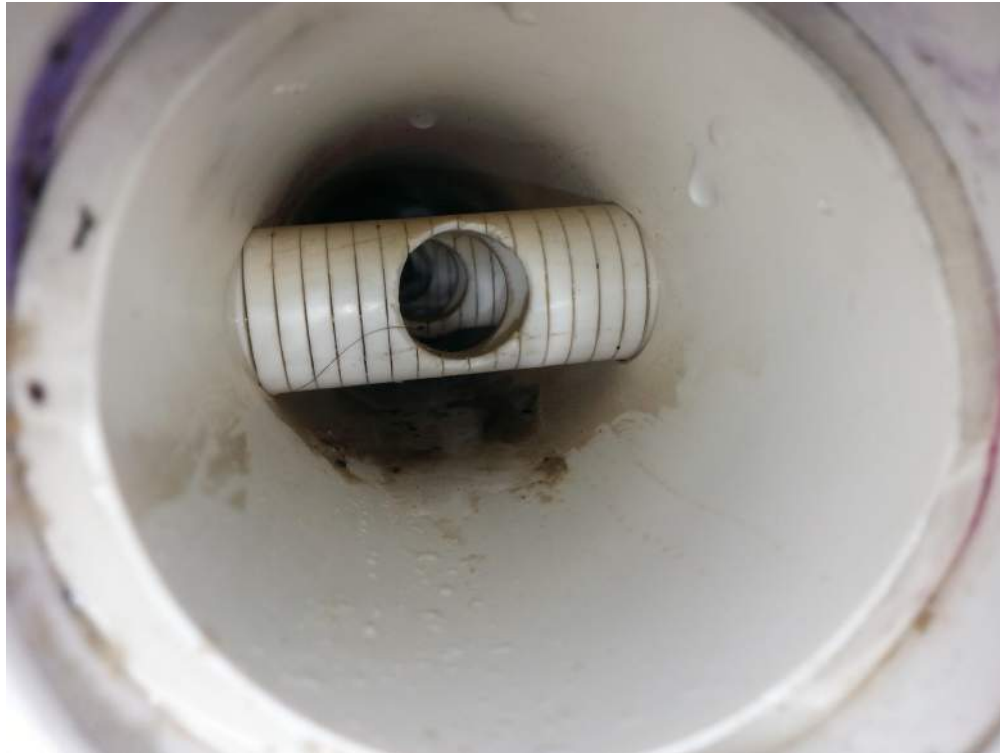
AguaClara Cross Sectional Layout

- More head loss than expected?
- Complicated head loss calculation
