AguaClara

Alternative Backwash without Slotted Pipes

Alberto Arnedo, Ainhoa Arribas, and Jorge Guevara

Cornell University

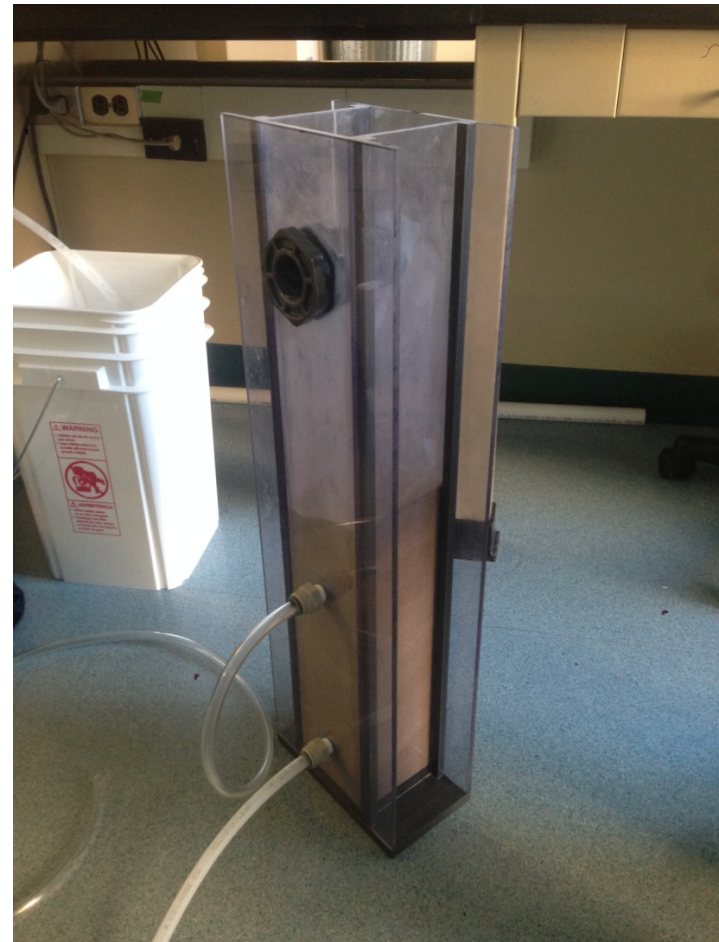
Alternative Pipe 1

- No sand accumulation while water was being pumped into the system during backwash.
- Sand accumulation in the outlet pipe during filtration.

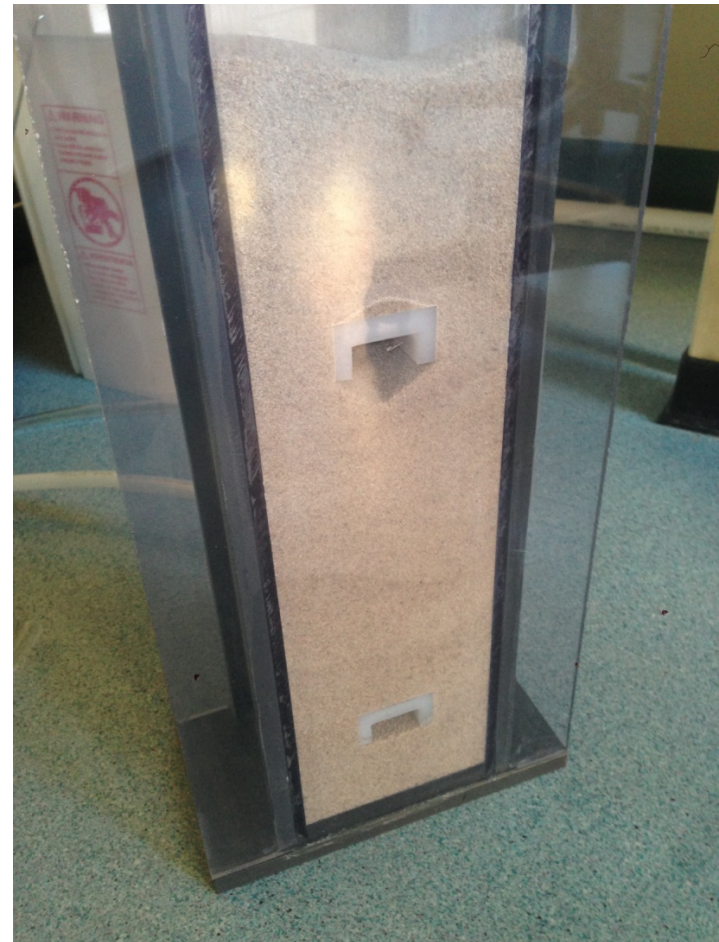
Alternative Pipe 2

- Sand filled up the pipe as soon as water began to pump into the system during backwash.
- During filtration, a mixture of sand and water left the outlet pipe.

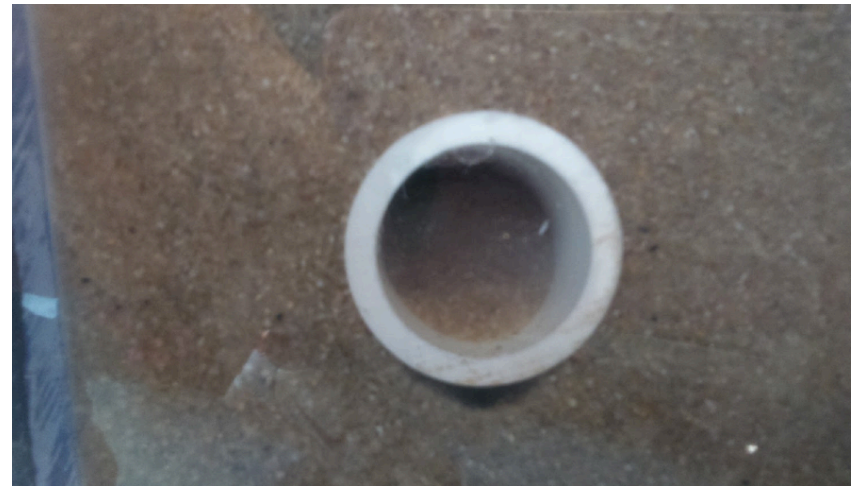
Alternative Pipe 3

- Slight sand accumulation during backwash.
- Slight sand accumulation in the pipe, however the sand did not exit the outlet valve during filtration.

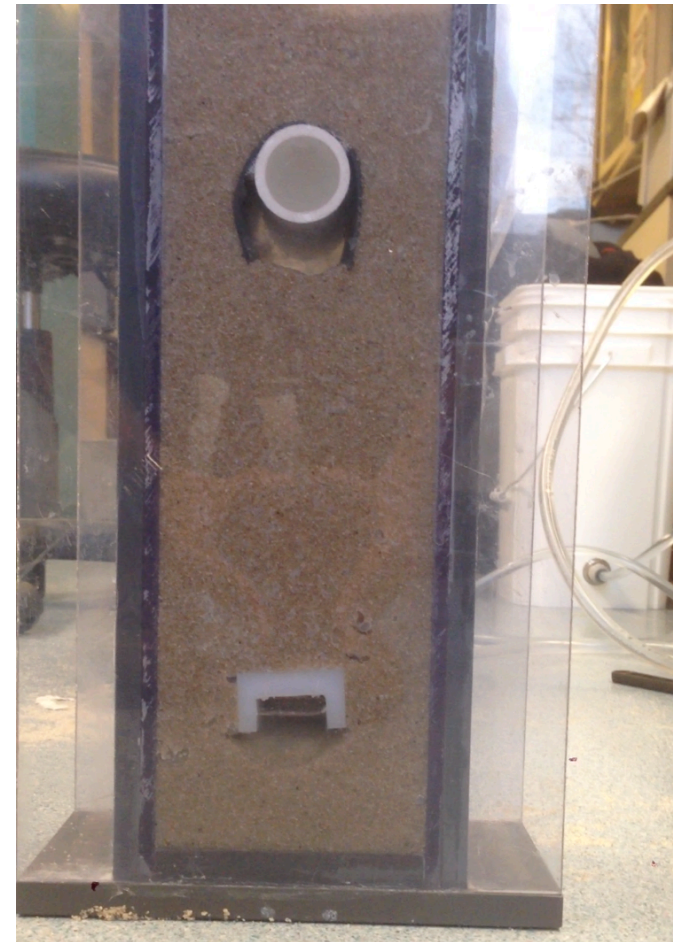
Alternative Pipe 4

- No sand accumulation during backwash.
- A plentiful amount of sand accumulation during filtration. Similar to alternative pipe 3, a mixture of sand and water came out of the outlet.

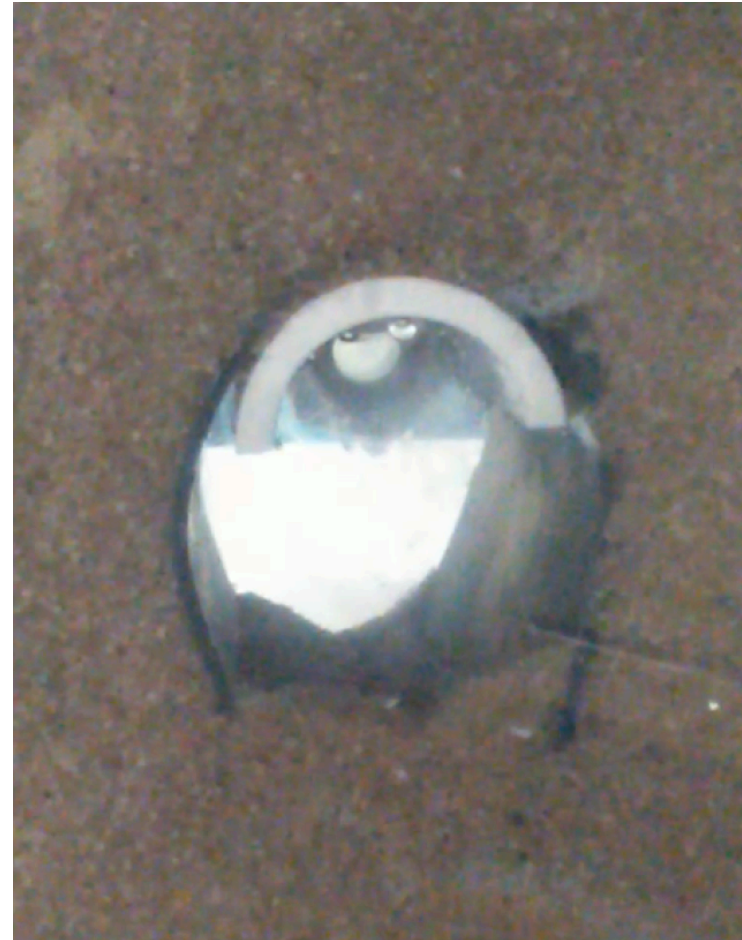
Issues Found

- The pump
- Gate valve
- Arrangement of the elements
- Water leakage
- Outlet pipe

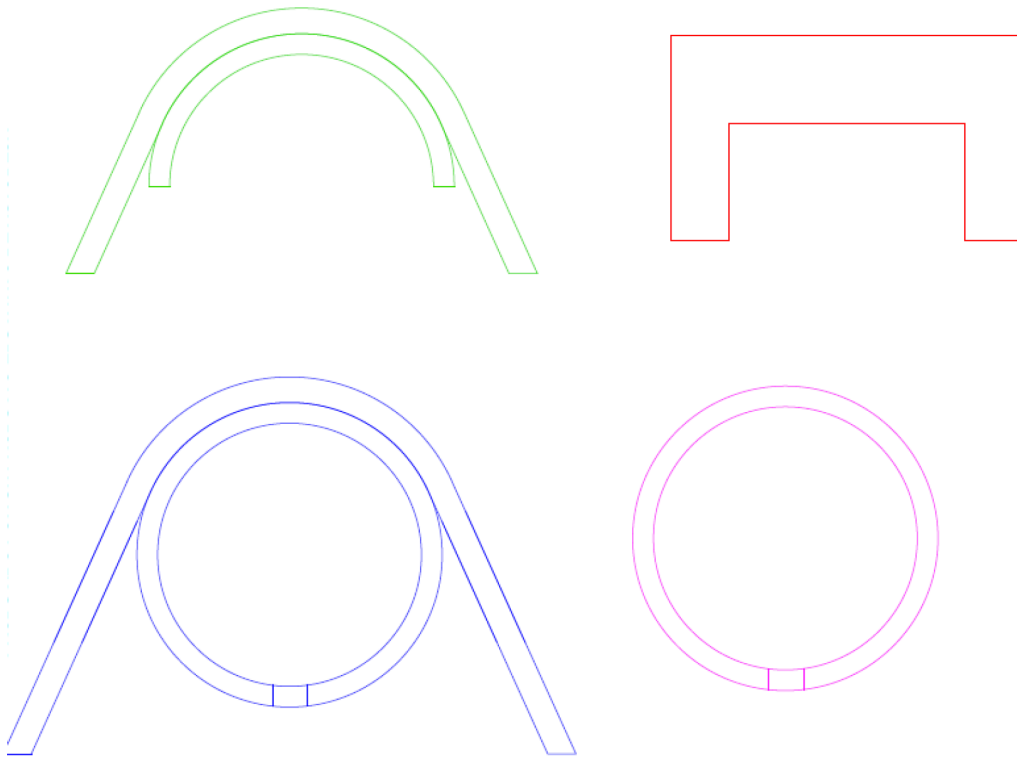
Conclusion

➤ U-Inverted shaped pipes optimal for backwash

➤ Filtration not solved

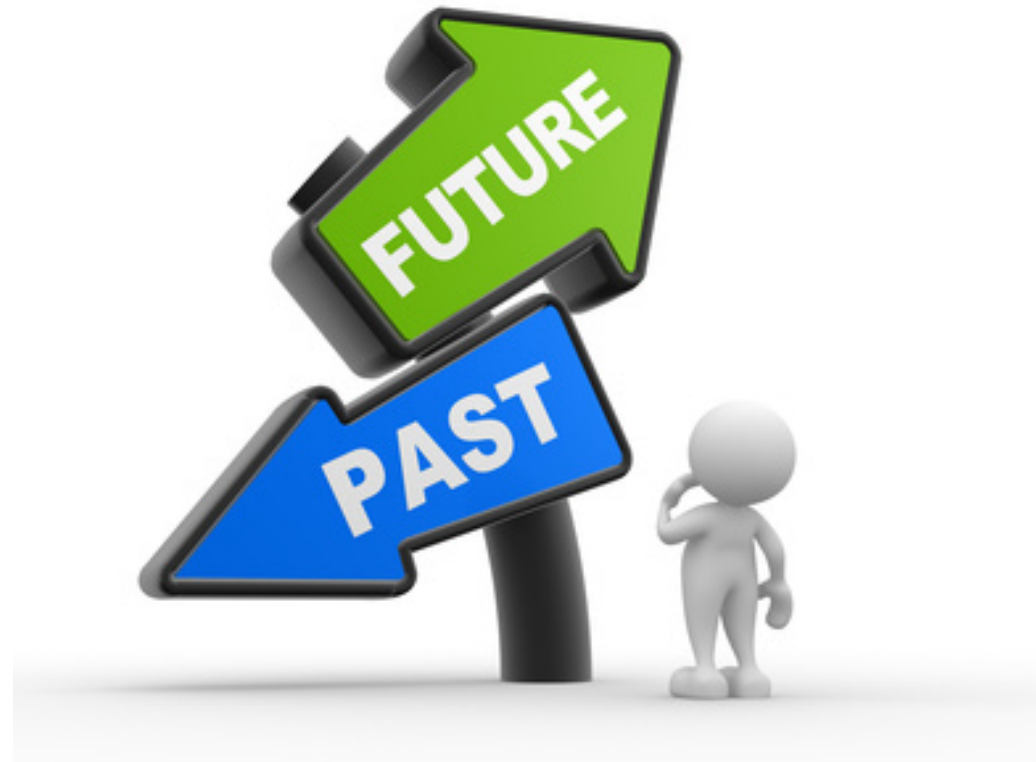
Future Work

- Avoid suction
- Sand clogging, perhaps the use of a mesh
- Size and shape of wings
