# Leaking Bulkhead Fittings

## Problem

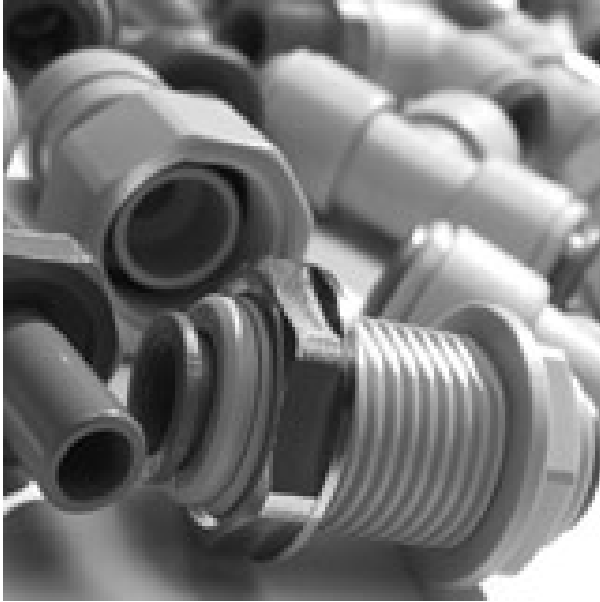
This is a new problem because this summer it was determined that John Guest, which is the company that produces the bulkhead fittings that are used at the plants, makes a bulkhead fitting that is made out of non-reactive polypropylene and not the potentially reactive acetal copolymer fittings that were previously used.

Unfortunately even though the polypropylene fittings look the same, they are assembled differently than the acetal fittings. As can be seen in the picture below the old acetal fittings consisted of one solid main body. The new polypropylene fittings consist of a two piece body.

Drill two holes, one on each side of the fitting. Each hole should only go as deep as the first piece of the body i.e. drill until you feel the end of the drill bit hit the second or inside piece of the body. Now you have one hole on each side of the body, each that only goes as deep as the outside of the second piece of the body. Next, acquire a tube of silicon caulk and cut the end of the insertion tube to the same diameter as the above holes that you have drilled into the body. Now, insert(squeeze) the silicone into the body through one hole in the body until you see it leak out the other hole. This will result in silicone filling the void between the two body parts and obstructing the flow of liquid through this path.

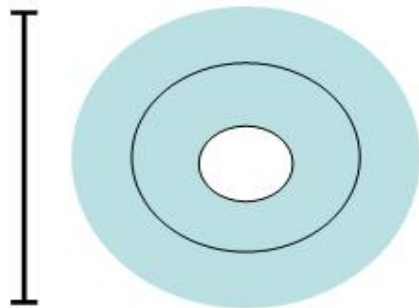
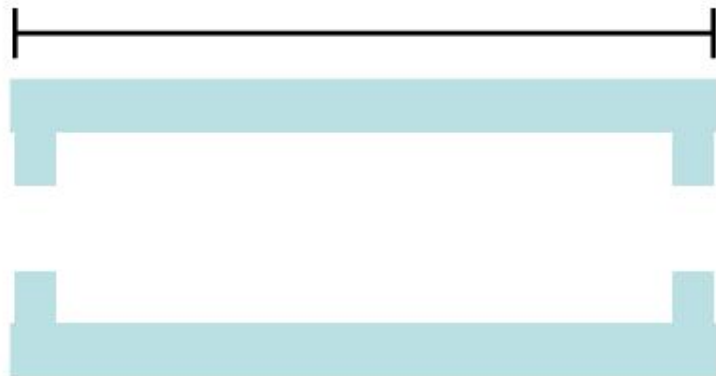
### Old Acetal Fitting

Front View

Cross Sectional View

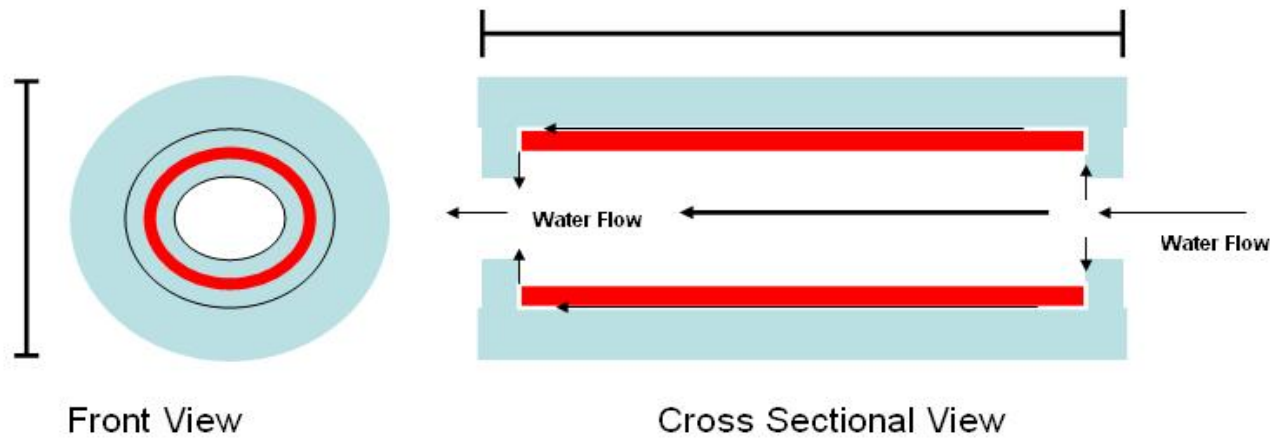
### New Polypropylene Fitting

We currently submerge one side of the polypropylene fittings in water, and intern, water has been flowing between the body pieces which is not sealed or reinforced with an o-ring.
