Ram Pump, Fall 2016

Javier Paternáin Martínez, Christopher Galantino, Luna Oiwa

December 10, 2016

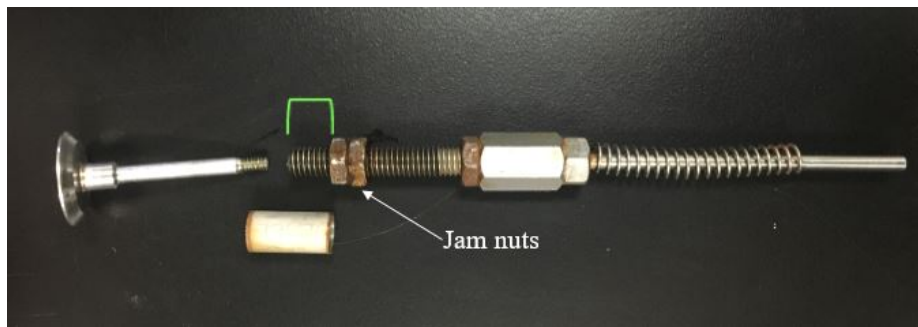
When the pump ceased to function after the addition of the distribution piping, the team hypothesized that a smaller plate amplitude would allow the check valve to close more easily and enable the pump to complete its cycles.

Figure 18: The length indicated in green shows the distance between the top of the rod and the nuts. The placement of the nuts determines the length of spring compression and therefore the amplitude of the check-valve plate. When the distribution pipe was added and the pump ceased to function, the nuts were placed closer to the top of the rod to decrease plate amplitude and increase the velocity of water passing through the check valve.

The ram pump was taken apart and the nut was reconfigured to 18.24 mm (0.718 in) below the top rod from its original position of 24.36 mm (0.959 in). This new position of the nut and collar was referred to as the new configuration and permitted the pump to resume its performance. This distance was chosen because the Spring 2016 found it to be optimal for pumping to 8 m of head, the team's zone of interest. Threshold and efficiency tests were also run in this new configuration without piping in order to serve as a comparison.

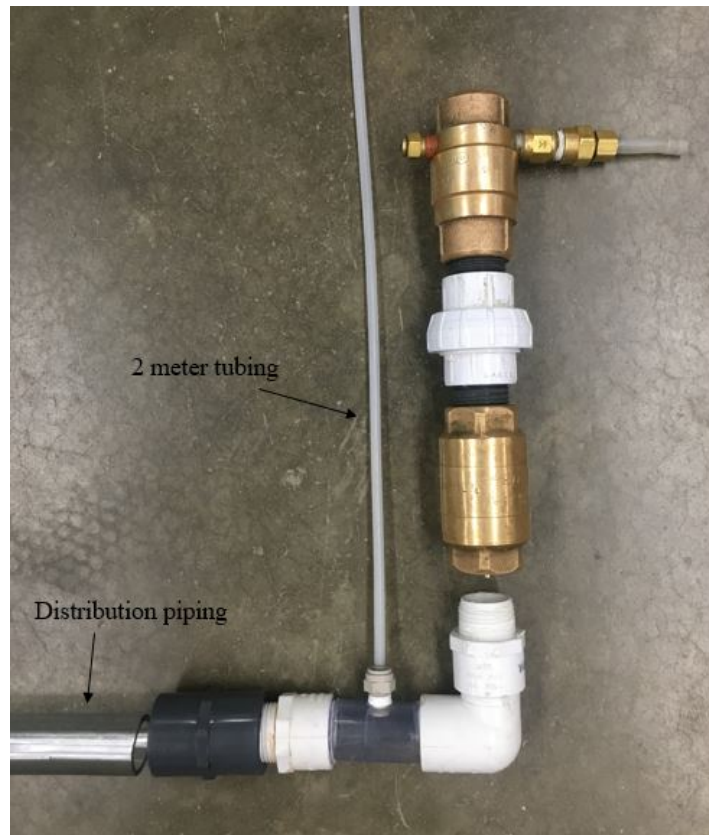
After the threshold and efficiency tests were performed with the distribution pipe in place, an opening was installed. A two meter, vertical tubing was attached to this opening to prevent water from leaking out of the system. The hypothesis was that bringing the system back to atmospheric pressure would increase the velocity of the water in the system, and consequently increase flow rate. However, the pump did not function at all after this actualization.

Figure 23: To bring the system back to atmospheric pressure, a small opening was added to the distribution pipe. A two meter, vertical tubing was attached to this opening to prevent water from leaking out of the system.

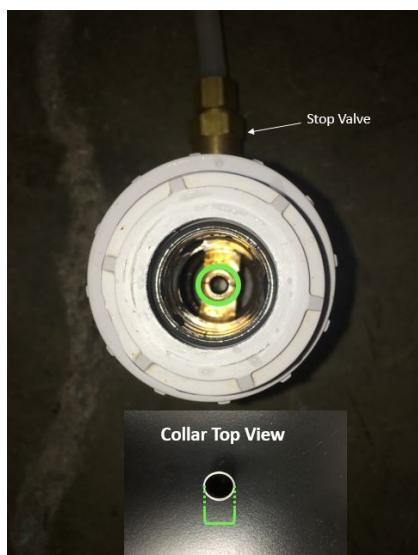
Another hypothesis to explain why the pump was not functioning was that the metal collar and spring fit over the rod were getting jammed due to incompatibility of parts. The metal collar was visibly rusted, and its edges were fraying. This was a point of concern because the excess metal had the potential to catch

(a) This is the collar placed on the top of the threaded portion of the rod, as seen from above. It appeared that as the collar rusted, it was getting caught on the bottom of the check valve. This was exasperated by the loose fitting of the collar over the rod and check valve.

on the bottom of the check valve. To address this problem, a washer was added between the check valve and the problematic collar. Because the diameter of the washer's opening was smaller than the diameter of the collar's opening, the washer would keep the two parts separated.

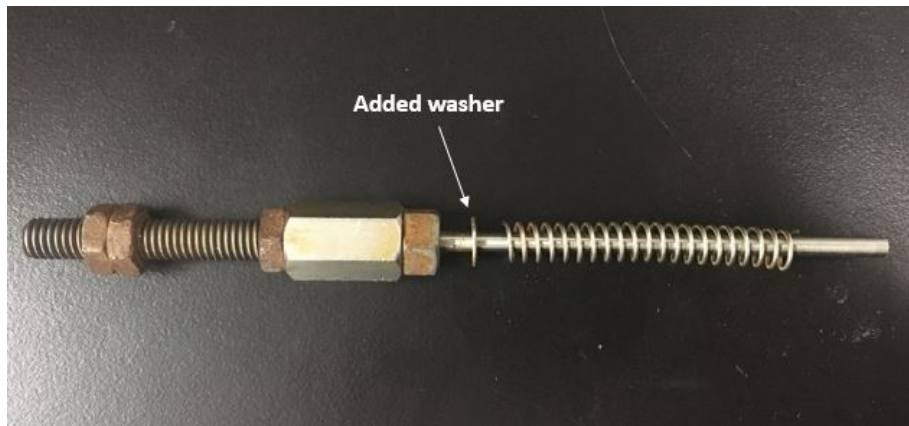
When the pump was being disassembled, it also became apparent that the top of the spring was getting caught on the lowest nut on the rod. To prevent this, a second washer was placed between the nut and the spring.

Figure 25: It appeared that the end of the spring was getting caught on the bottom nut. Another washer was placed between the two parts in order to prevent jamming.
