**Cornell University**  
**Environmental**  
**Health and Safety**

## MEMO

**Subject:** JanFab – Upson Hall

EHS conducted various site inspections and monitoring of different work activities during the time frame called JanFab within B70, B70E Upson Hall and 101 of Upson Automotive Lab. Attendees included Phil VanChieri, Greg Smith, and Blaine Harteis, EHS.

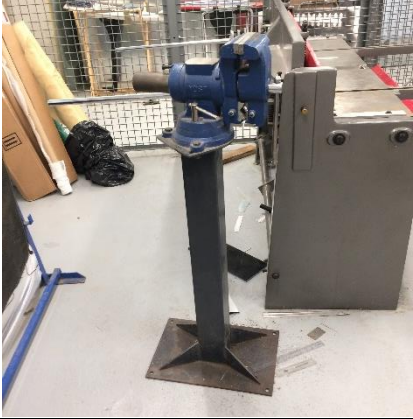
<p>Recommend removing and disposing of half-face respirators.</p>
<p>Upson Hall - B70E- bench top drill presses and floor stand vise are not bolted down.</p>

<p><b>1910.212(b)</b> Anchoring fixed machinery. Machines designed for a fixed location shall be securely anchored to prevent walking or moving.</p>

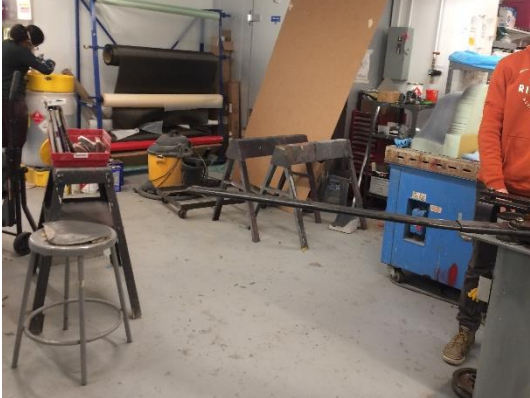
<p>machine is removed to keep egress path clear</p>
<p>Upton Hall – B70 – Inadequate working surface, improper gloves, Awkward posture/improper ergonomics. Power cords pose a tripping hazard.</p>

<p>Recommended giving the miter saw a designated working surface that avoids students getting into awkward positions or that are ergonomically hazardous. Specifically, on a table that is at a comfortable height for the user. Cover the power cord or place them where students cannot trip over them.</p> <p>Position saw so the cuttings/dust is in the direction of the air flow within the paint booth.</p>
