# Fall 2008 Paint Test

## Fall 2008 Paint Test

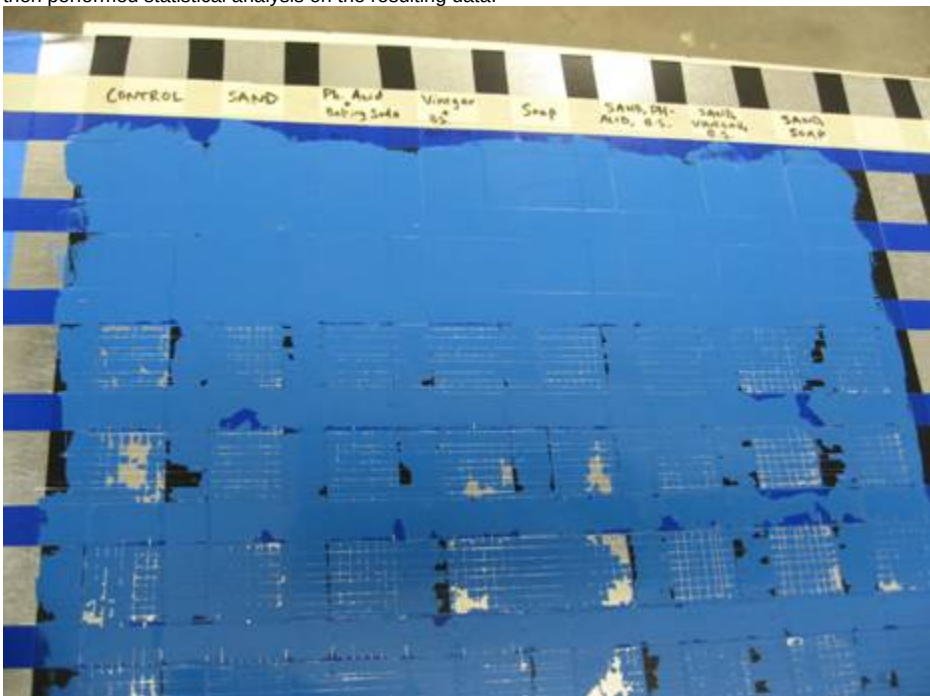
Next we painted all the pretreated areas and allowed the paint to dry for several days. Using a sharp knife, we scribed 5x8 (~3 mm cell) grids into each pretreated area. Thus, each grid had 64 one square millimeter squares of paint that were not attached to each other. After that, we used the stickiest tape we could find (duct tape), adhered it to each grid, and then ripped it off. We counted the number of squares removed from each grid in that fashion and then performed statistical analysis on the resulting data.
