Cuatro Comunidades Sedimentation Tanks

Abstract

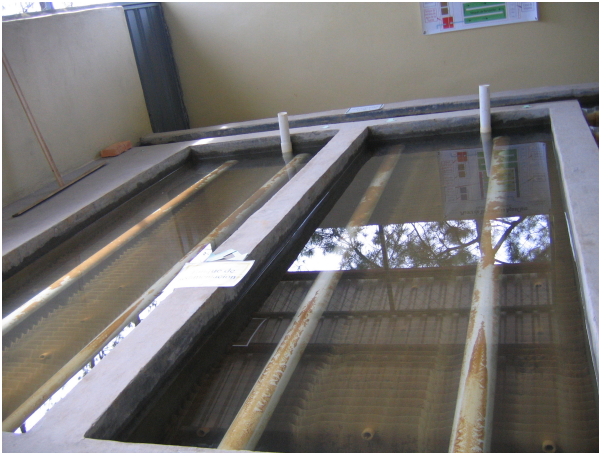
Sedimentation Tanks at the Cuatro Comunidades plant

For the Cuatro Comunidades plant design the depth of the two sedimentation tanks was reduced by almost half a meter from 2 meters to 1.55 meters to cut construction costs. The tanks were designed to accommodate a floc blanket which would improve effluent quality. No concrete evidence of a floc blanket had been seen before the study. One tank was shut off in an attempt to form a floc blanket. Additionally the effluent water turbidity was compared to the settled water turbidity at the end of a tube settler to determine if the sedimentation tanks were working efficiently.
