Chemical Safety, Fall 2015

Anna Doyle, Deniz Yilmazer

12/02/2015

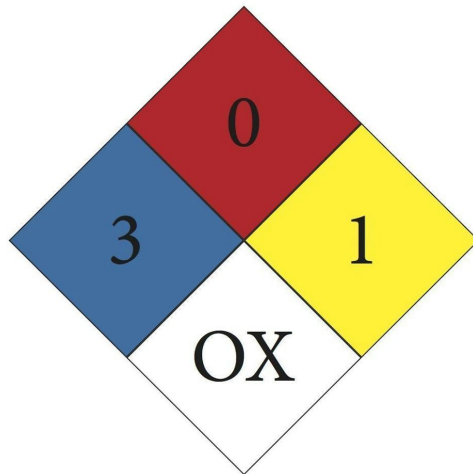
Cloro Granular

Figure 4: Fire Diamond for Granular Chlorine

The team also created fire diamonds for the plants to use. In the Figure 4 below, the fire diamond for granular chlorine may be seen as an example.

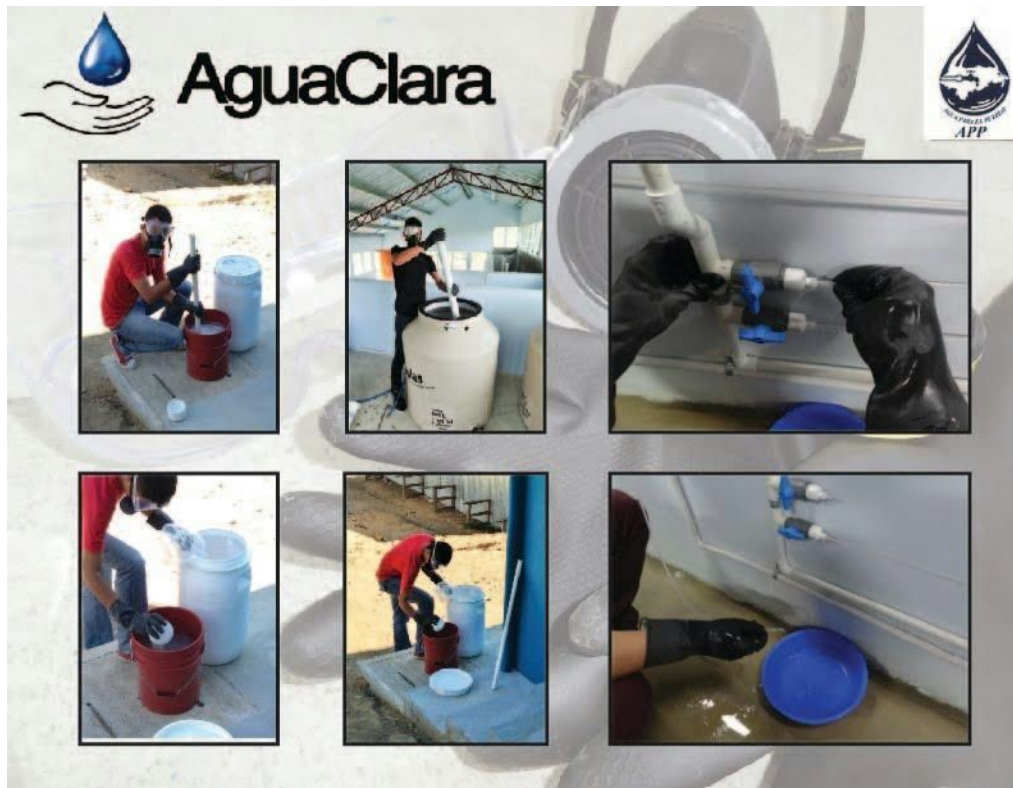
Figure 6: Use of PPE Poster

The team also created posters to be used in the AguaClara plants that would act as a reminder for the employees to use necessary PPE for the specific task they undertake. Some examples can be seen below. Figure 5 presents the overall plan of the plant and show the PPE necessary in each part while Figure 6 presents correct use of the PPE while performing a common task in the plant.
